Refugee Resilience in the Middle East: An Explanatory Analysis of Syrian Refugee Camps in Jordan

Abstract—This study focuses on the sheltering response in the Middle East, specifically through reviewing two Syrian refugee camps in Jordan, involving Zaatari and Azraq. Zaatari camp involved the rapid deployment of tents and shelters over a very short period of time and Azraq was purpose built and pre-planned over a longer period. At present, both camps collectively host more than 133,000 occupants. Field visits were taken to both camps and the main issues and problems in the sheltering response were highlighted through focus group discussions with camp occupants and inspection of shelter habitats. This provided both subjective and objective research data sources. While every case has its own significance and deployment to meet humanitarian needs, there are some common requirements irrespective of geographical region. The results suggest that there is a gap in the suitability of the required habitat needs and what has been provided. It is recommended that the global international response and support could be improved in relation to the habitat form, construction type, layout, functi

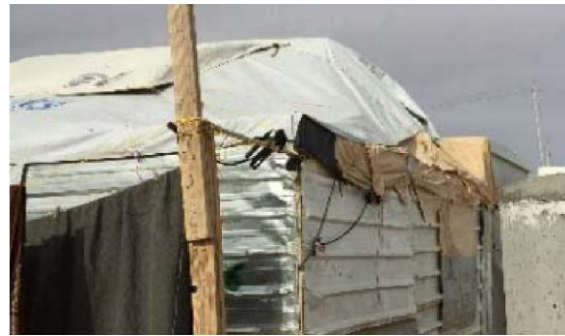
Fig. 6 Extended area example [13]

In an attempt to seal the shelters, especially the roof-wall junctions (Fig. 5), the residents covered the roofs using fabrics they had or bought them, if they could afford them. Some families also tried to expand their shelters by enclosing a space using corrugated sheets and then covered it with fabric,

which is not a durable solution and cannot replace a proper roof (Fig. 6). The expanded area fulfilled some major needs such as providing separated sleeping areas for different genders and ages within the family, or providing a separate area for socializing and receiving guests. Social interaction can be an important aspect to communities in general. This is perhaps more critical for refugees to assist interaction and alleviate the trauma of leaving their home and country.

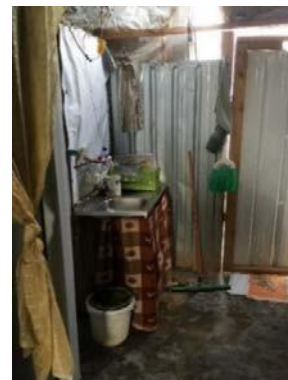
Fig. 8 Self-built kitchen [13]

- **Facilities:** When the camp was first opened, the kitchens and toilets provided were communal. Problems occurred when using such communal facilities from both cultural and privacy/security perspectives. It was found that when residents could afford some materials, they adapted and self-built private facilities adjacent to their shelters. These adaptations included enclosing additional space with corrugated sheets, wood and canvas, if the residents were able to afford materials (Figs. 8 and 9).
- **Outdoor areas:** The courtyard is an important cultural feature in Syrian homes and enclosing an outdoor space was found to be very important to the camp residents. They often enclosed a space next to their shelter or between two shelters with canvas or corrugated sheets, as shown in Fig. 10. One of the main benefits of such a

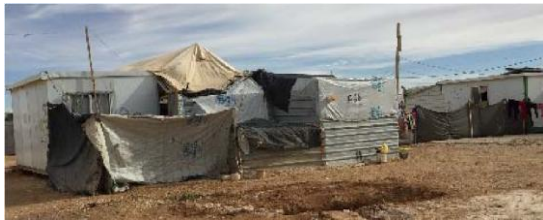
Fig. 10 Private outdoor area [13]

private area was for women residents to have access to an outside space. This provided safety, privacy and aligned to their cultural needs.

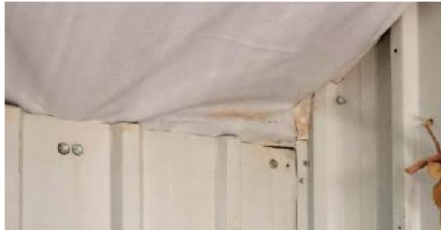
Fig. 14 Sharp edges in cladding [15]

- *Walls and roofs:* The junctions between the walls and the roof are not well-sealed and were found to leak water and dust. Residents mentioned they preferred a flat roof rather than a pitched roof, as they thought this would be easier to seal and it was more familiar to them. Due to the camp's strict policies regarding making any changes to the shelters, residents could not change the roof. The wall heights were low; however, the pitched roof design did provide more head-room. The overlapping of the internal metal cladding sheets

resulted in sharp edges, as shown in Fig. 14, and residents had stated that injuries had occurred.

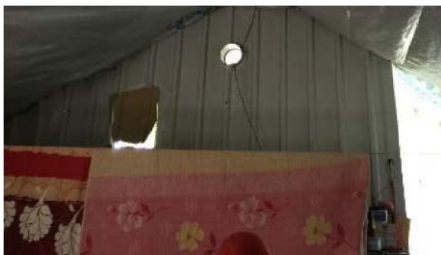
Fig. 15 Blanket dividers [15]

The shelter is a basic design involving a one-room plan. The original design had indicated 'partitioning wires' to support fabric room dividers, but were never installed. Residents believe that it is not acceptable culturally nor religiously to have different ages and genders sleeping in the same room. They erected their own fabric dividers using their own sheets or blankets as and when required (Fig. 15).

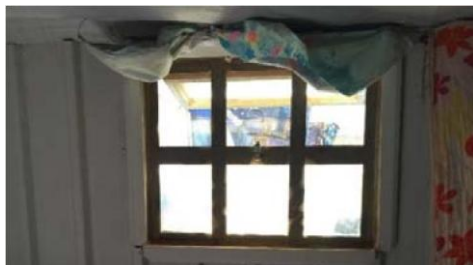
Fig. 16 The T-shelter window [15]

- **Windows:** Shelters in Azraq camp have only one small window (Fig. 16). The problem is increased as residents close their windows and shade them using fabrics because they directly overlook public areas or other residents' windows and do not provide adequate privacy.

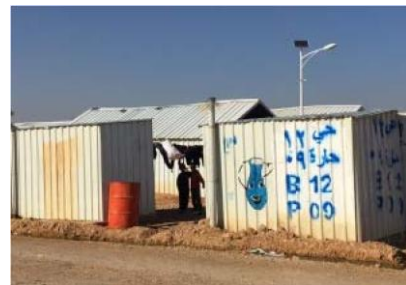
Fig. 19 Communal unit for toilet and shower [15]

- **Facilities:** Toilets are communal in Azraq camp and each unit (toilet and a shower) is used by approximately three families (Fig. 19). Residents had ceased to use the communal showers due to safety concerns and opted to shower in their own shelters using buckets of water. The shelters were not designed to have internal showers nor is their space provision. The main difficulties regarding using communal facilities are:
 - hygiene problems: used by large numbers,
 - distance problem: using the toilets in winter is problematic, especially for children, due to the distance and the harsh weather,
 - ground turns into mud after raining, and

- lack of security and safety: specifically, for children and women at night.

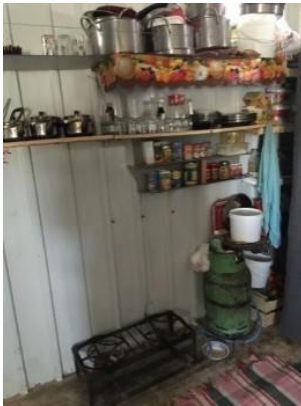
Fig. 20 Kitchen tools [15]

The residents were not provided with private or communal kitchens. Cooking equipment was given to residents to utilize in a corner of their shelters as a kitchen space. This included stoves and gas cylinders as shown in Fig. 20. Cooking inside the shelters was one of the causes behind the respiratory problems the residents had mentioned.

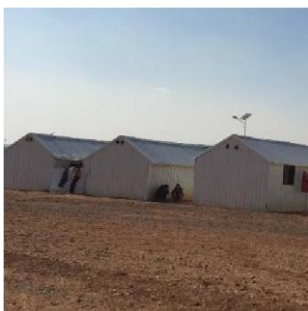
Fig. 21 Original gap between shelters [15]

- *Outdoor areas:* There are privacy concerns in the camp and an absence of private social spaces whether outside or inside. Fig. 21 illustrates residents sitting in the shade close to the edge of an external wall. This shows the importance of this external space for socializing. The residents tried to overcome the problem by removing the inner lining of the shelter roof (plastic sheeting) to use as an exterior partition to form a private outdoor space (Fig. 22).

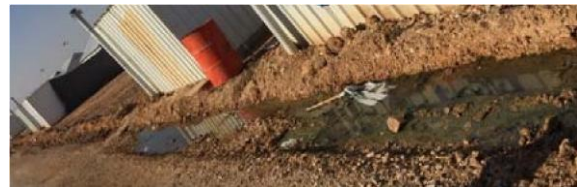
Fig. 23 Surface runoff wastewater [15]

- *Drainage:* The absence of a drainage system is a problem in the Azraq camp. The residents formed ditches to outside pits and aligned different ditches to form a network of surface wastewater channels adjacent to the streets, as shown in Fig. 23. In addition to hygiene problems, it also leads to accessibility issues for people with special needs and elderly, trying to cross over the wastewater.

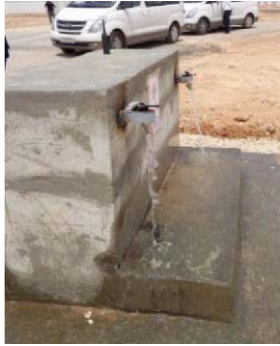
Fig. 24 A water tap [15]

- *Water and electricity:* Water taps are distributed around the camp, as shown in Fig. 24, and are piped from the primary main water tanks located on the camp edge. There is approximately one tap for every three blocks and operates from 7 a.m. – 12 p.m. and from 7 p.m.-12 a.m. Residents fill up bottles or containers (if they have enough) for their daily usage. There is no limit for the amount of water they can take, but there is long distance to reach the closest tap. Children are the primary water carriers, which can be up to 20 liters per day according to the residents.

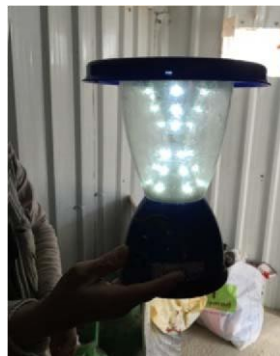
Fig. 25 Solar lamp [15]

The only source for electricity in the Azraq camp is solar lamps (Fig. 25). Shelters have one or two lamps but no additional devices, other than mobile phones, can be operated by these lamps.
